**Technical Evaluation Memorandum  
for the Radiation Technology  
Superfund Site, Operable Unit 3  
Contract No. W912DQ-11-D3006**

**Site Number NJD047684451**

**December 2012**

**Photographs of Site  
Buildings/Structures from October  
2012 Site Walk**

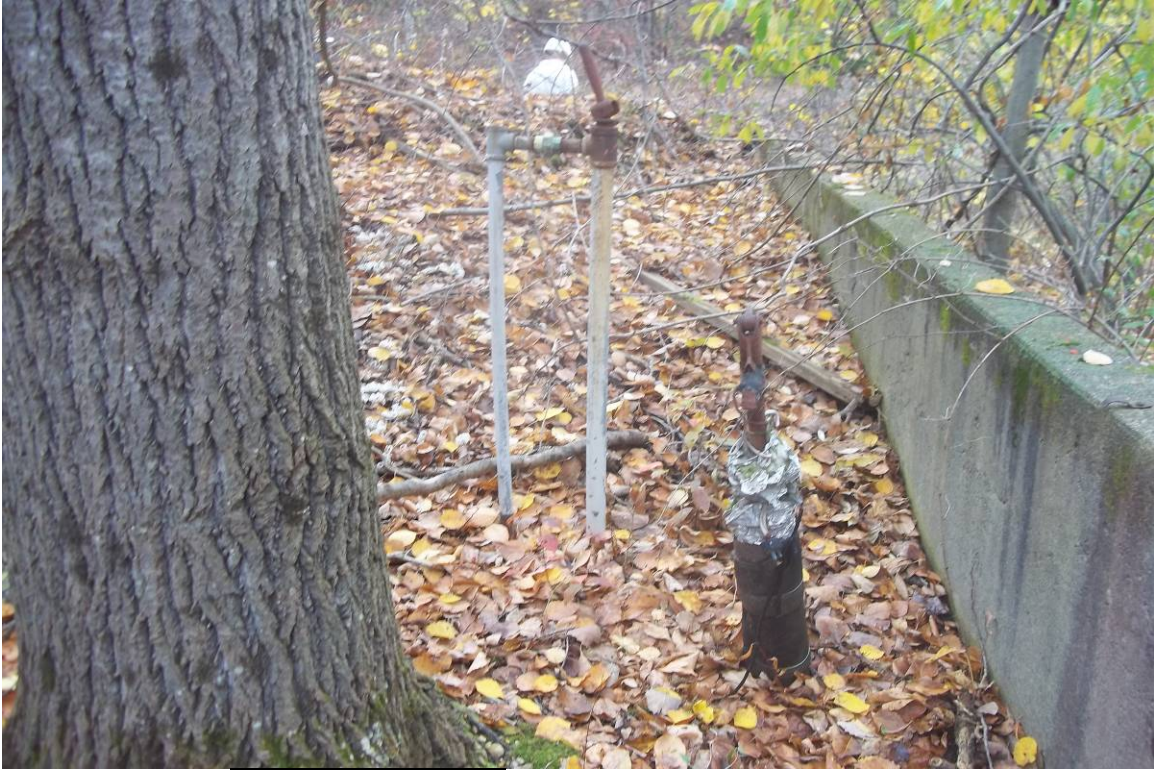
**Subject:** Acid storage area in P2 Area. At north end (foreground of photo) is well with heat tape and spigot.

The storage tanks have been removed and are assumed to have been ASTs (due to the presence of a containment wall). Pipes in the northeast corner of the containment area appear to be water and chemical lines. E & E recommends collecting one surface soil sample from near the pipes.

The containment area is currently filled with debris (predominantly plastic waste), which appears to be from the “Rad” nut and bolt manufacturing process. Further investigation of this debris (hand digging) is recommended to investigate the presence of potential hazardous materials. E & E proposes to collect two surface soil samples within the containment, and two concrete chip samples (if a concrete floor exists) for general characterization purposes and for use in the FFS.

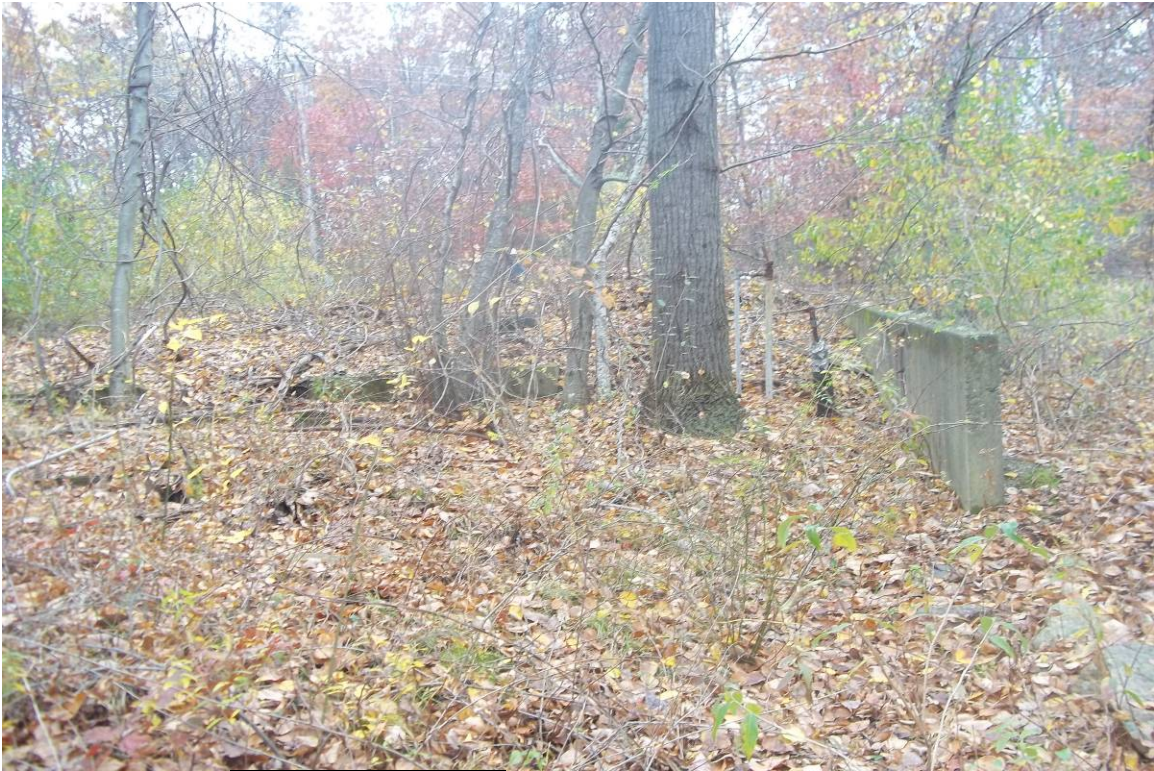
**Subject:** Acid storage area in P2 Area.

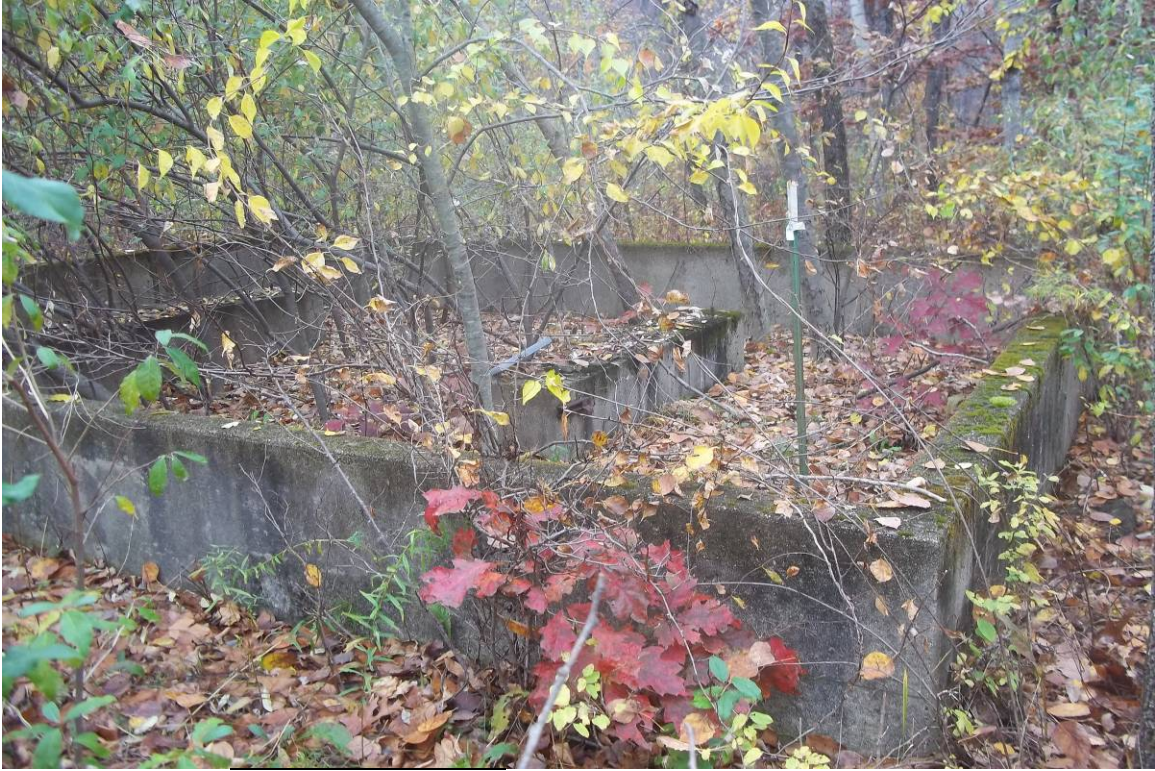
**Date/Time:** 10/25/2012 **Subject:** Fuel storage area looking south.

The fuel storage area is currently concrete foundation, no tanks were observed.

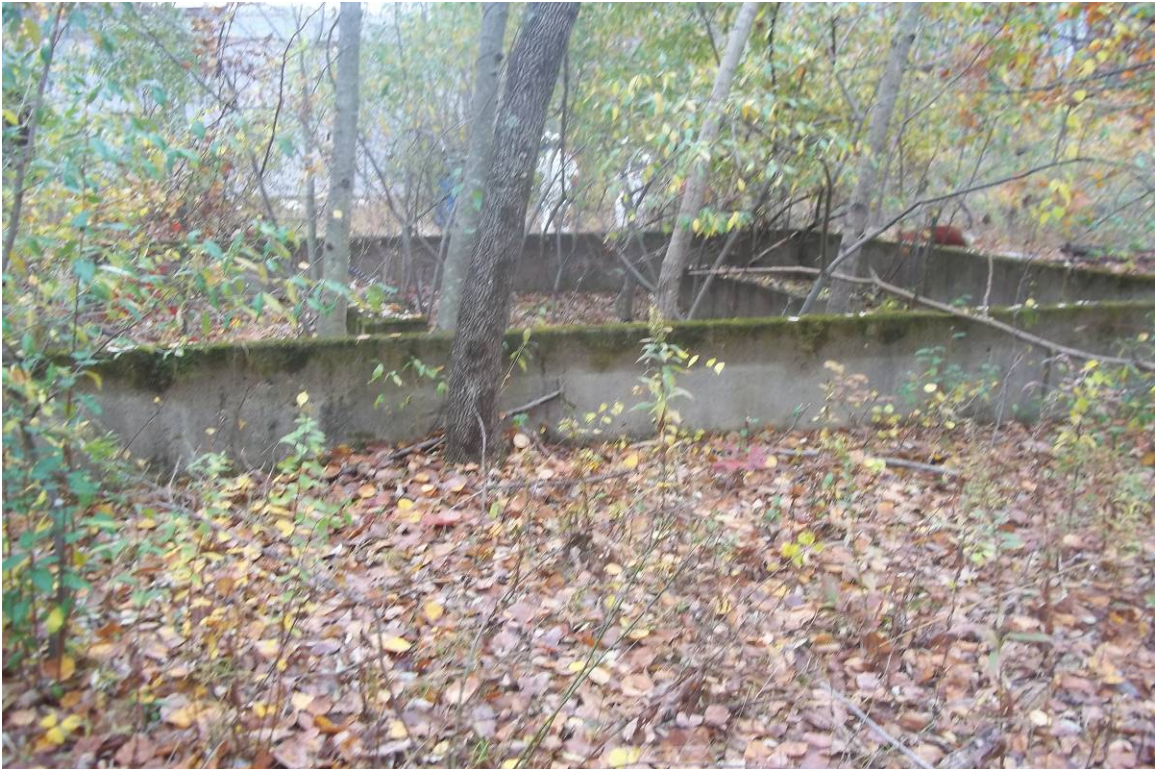
**Date/Time:** 10/25/2012 **Subject:** Fuel storage area looking north.

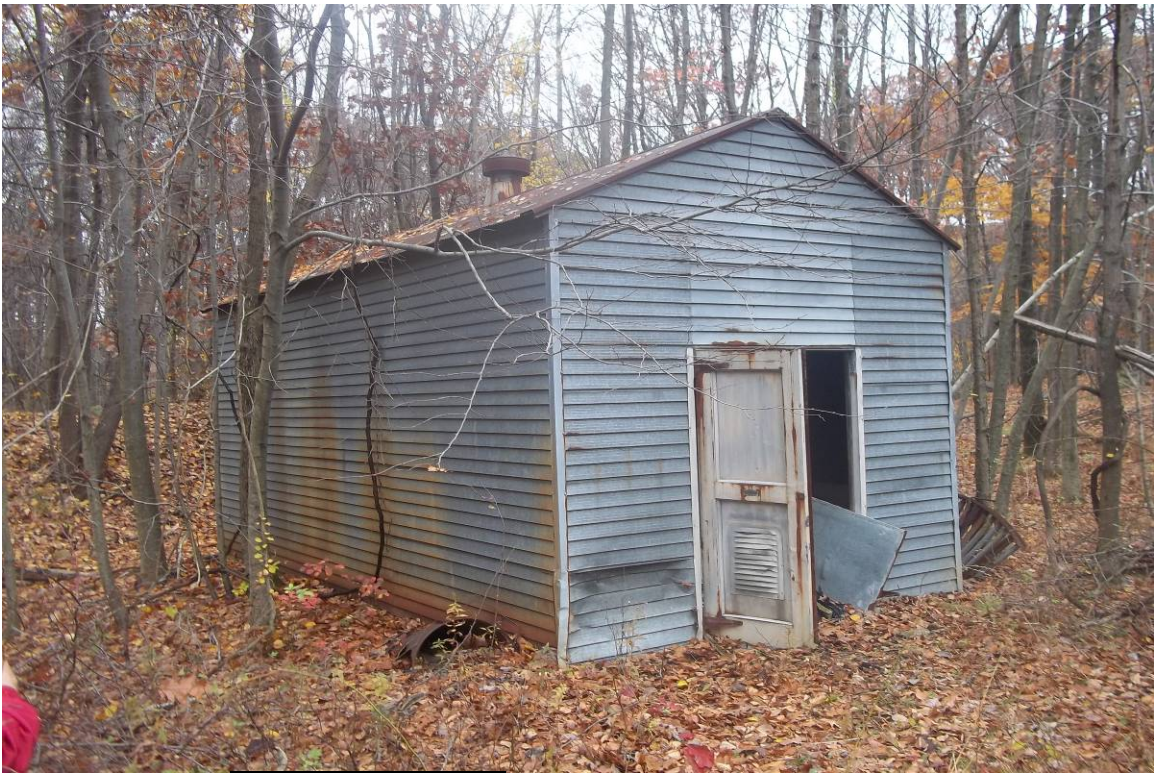
**Date/Time:** 10/25/2012 **Subject:** South side of igniter building (entrance).

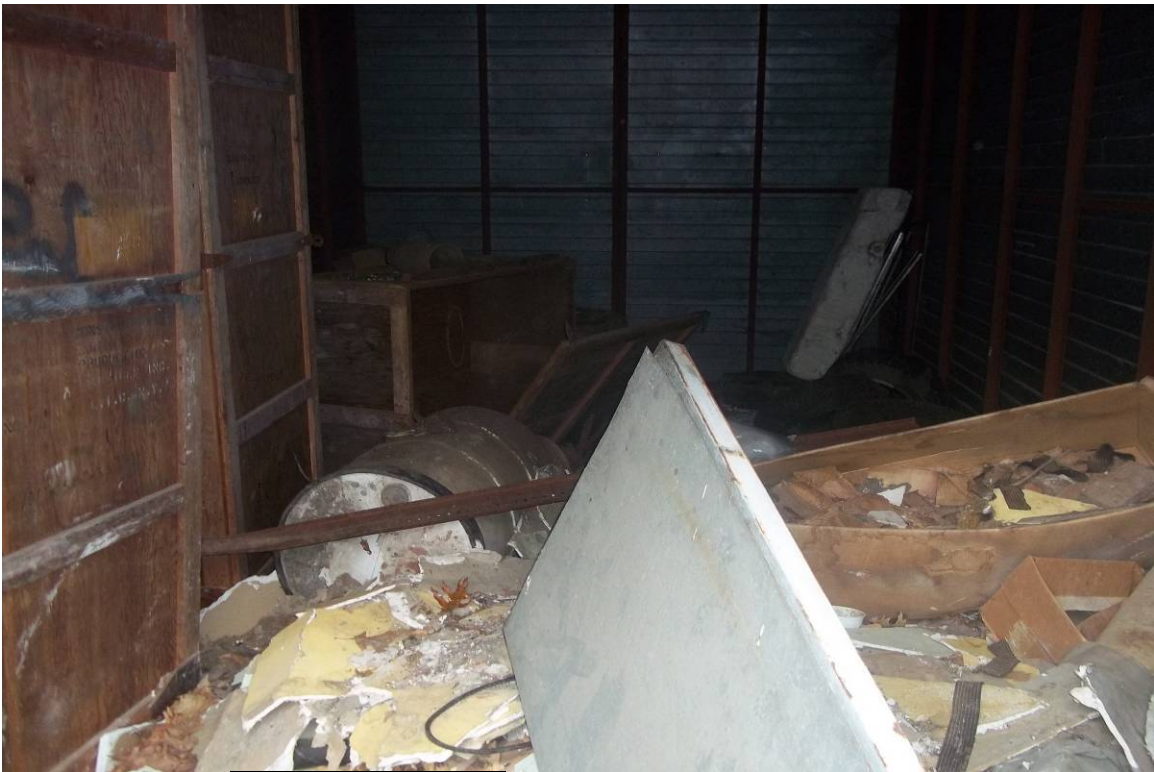
**Date/Time:** 10/25/2012 **Subject:** Interior of igniter building.

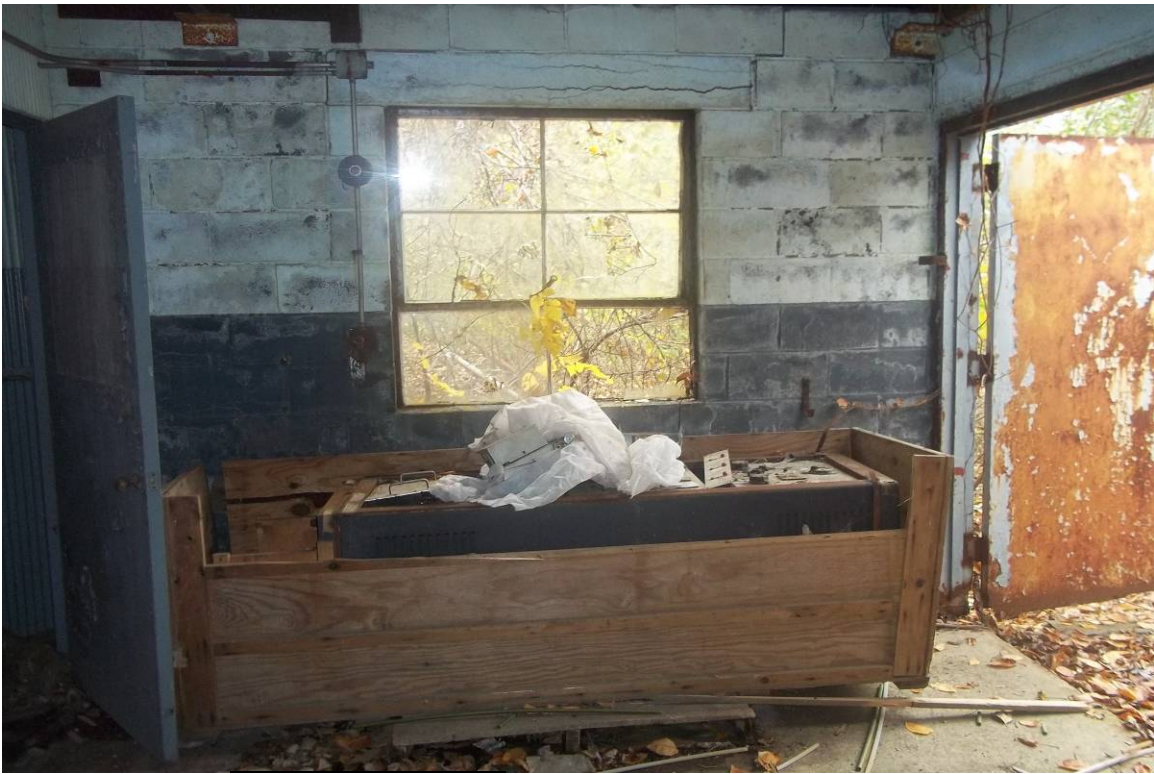
**Date/Time:** 10/25/2012 **Subject:** Interior of building R-34 located in P2 Area.

Both diesel engine test stand rooms were cored and sampled (R-34A and R-34B) (see Figure 1-2) by Lockheed Martin. R-34B was collected beneath a fracture in the foundation (Lockheed Martin SERAS 2010). Both sub-slab samples were analyzed for metals, VOC, energetics, and SVOCs. Both samples contained concentrations exceeding their respective action levels in several metals, and two SVOCs. Arsenic had a concentration of 3.6 mg/kg in R-34A, which is more than nine times the action level at 0.39 mg/kg (Lockheed Martin SERAS 2010). Iron had a concentration of 20,400 mg/kg in R-34A, which is more than eight times the action level at 2,300 mg/kg (Lockheed Martin SERAS 2010). Benzo(a)pyrene had a concentration of 440J ug/kg in R-34A, which is more than six times the action level at 62 ug/kg (Lockheed Martin SERAS 2010). Results are included in the Summary of Previous Sampling Results sheets in Appendix C.

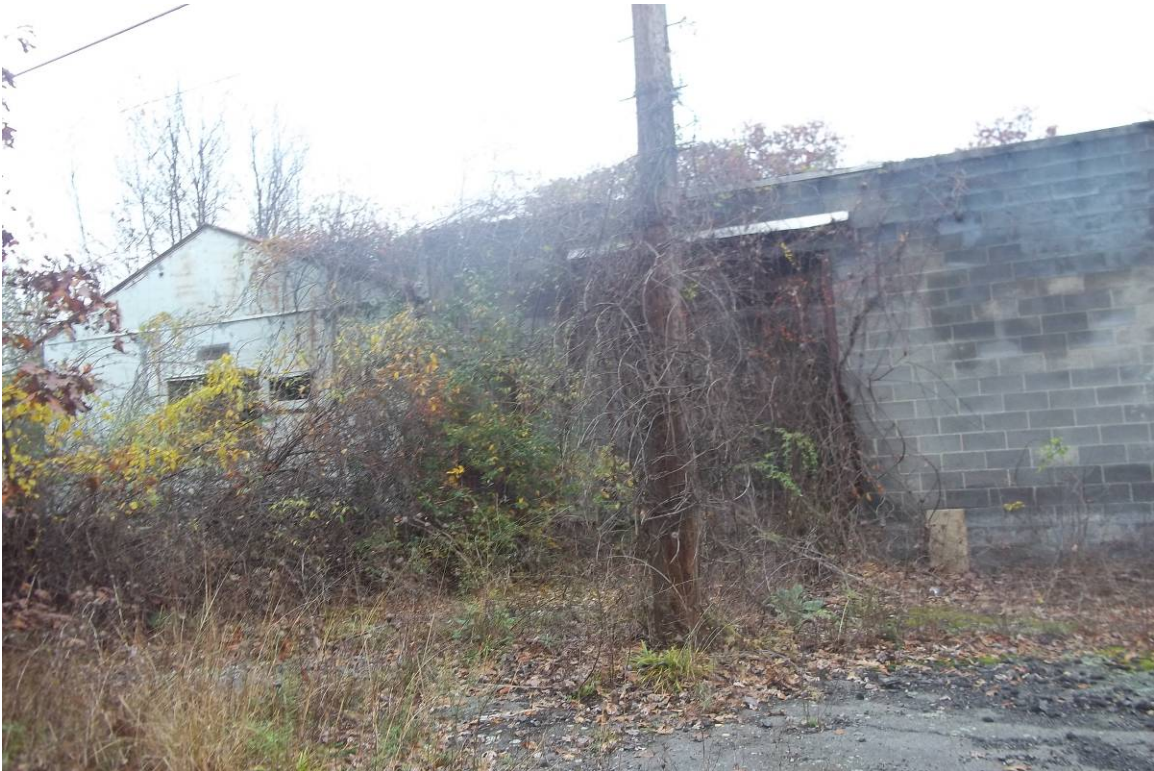
**Date/Time:** 10/25/2012 **Subject:** Exterior of building R-34 located in P2 Area.

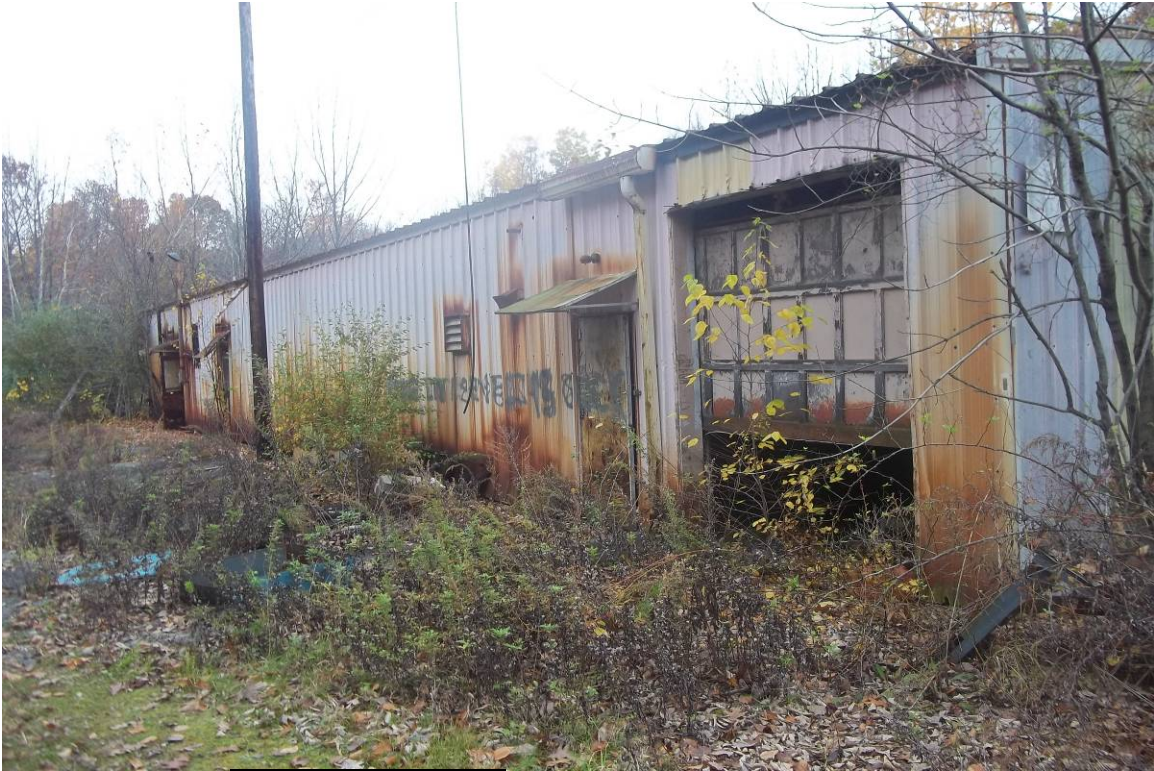
**Date/Time:** 10/25/2012 **Subject:** Exterior of building R-47 in P2 Area.

R-47 is an unoccupied large building/warehouse (approximately 190 by 74 feet) with galvanized sheet metal, steel framing, and utilities. It was historically used as a rocket fueling station for the Bullpup B rocket. R-47 contained six rocket fueling bays with an overhead crane and tracks that were used to move the rockets. It was also used for rocket motor assembly, and later fiberglass boat manufacturing, machine shop, and auto restoration. An AST (possibly a heating oil tank) was observed on the west side of the building.

Recommend removal of four drums (three contain petroleum products and one contains an unknown liquid) located inside the building. All of these drums had elevated photoionization detector (PID) readings (ranging from 15 ppm to up to 90 parts per million [ppm]) above the background readings of 0 ppm. Three of the drums were labeled, but the fourth drum did not contain a label, therefore, this drums needs to be sampled or hazard categorized prior to disposal. Two of the drums have leaked onto the floor, therefore, E & E recommends collecting two concrete chip samples inside the building near the drums, and one from the south end for general characterization of the building floor (0 to 1 inch deep) for estimating disposal costs/options in the FFS.

There is a possible UST outside the boiler room on the northwest side of the building, based on the presence of what appears to be a vent pipe sticking out of the ground. E & E recommends using a metal detector to determine if an underground storage tank (UST) is present, and/or hand excavating around the vent pipe to help verify the presence or absence of a tank. If an UST is located, E & E recommends sampling of the tank's contents.

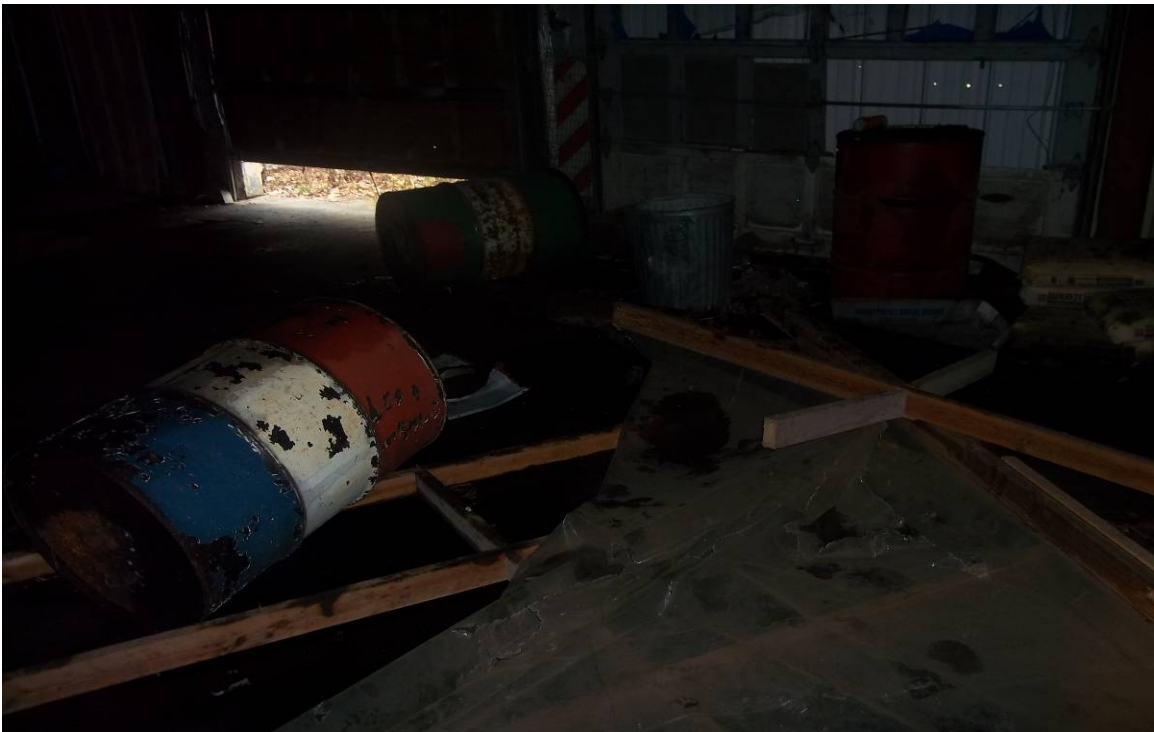
**Date/Time:** 10/25/2012 **Subject:** Interior of building R-47 in P2 Area.  
Numerous 55 gallon drums present.

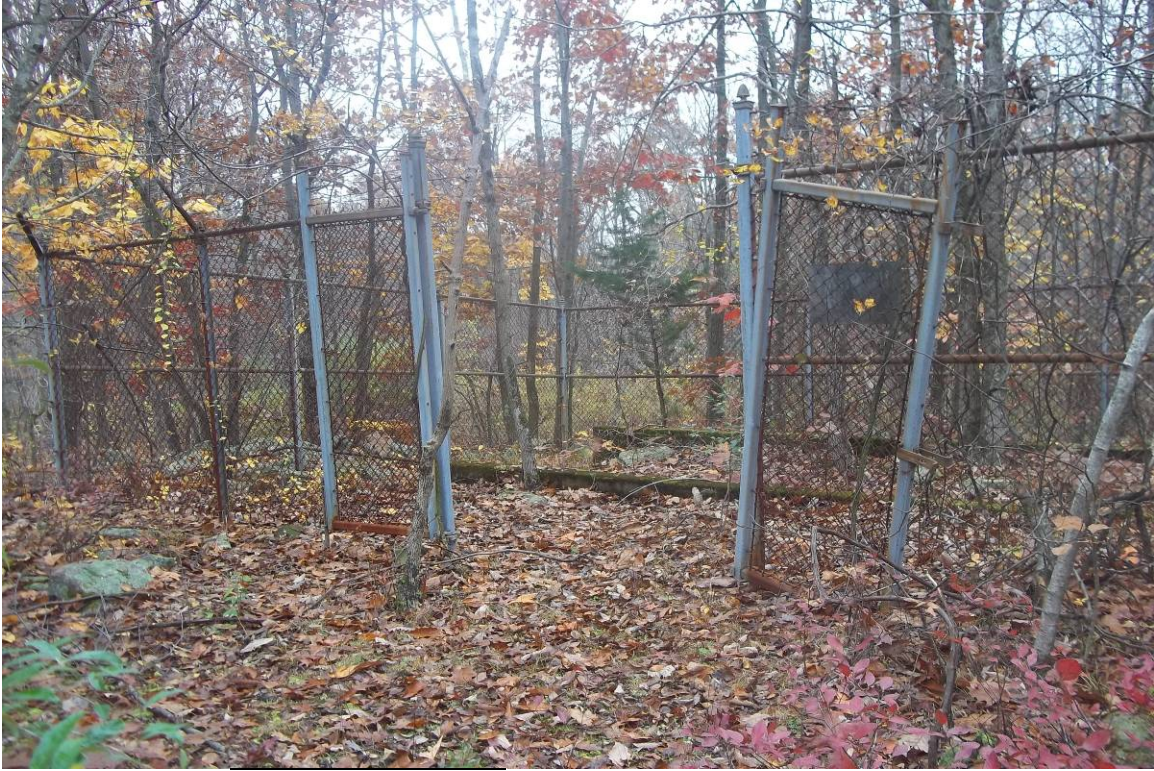
**Subject:** Looking northwest at propane storage area  
within the South Stand Area.

This former propane storage area currently only contains a chain-link fence, piping, and concrete foundations. Based on previous/current use there should be no source for spills, and due to the absence of staining, no additional sampling is recommended.

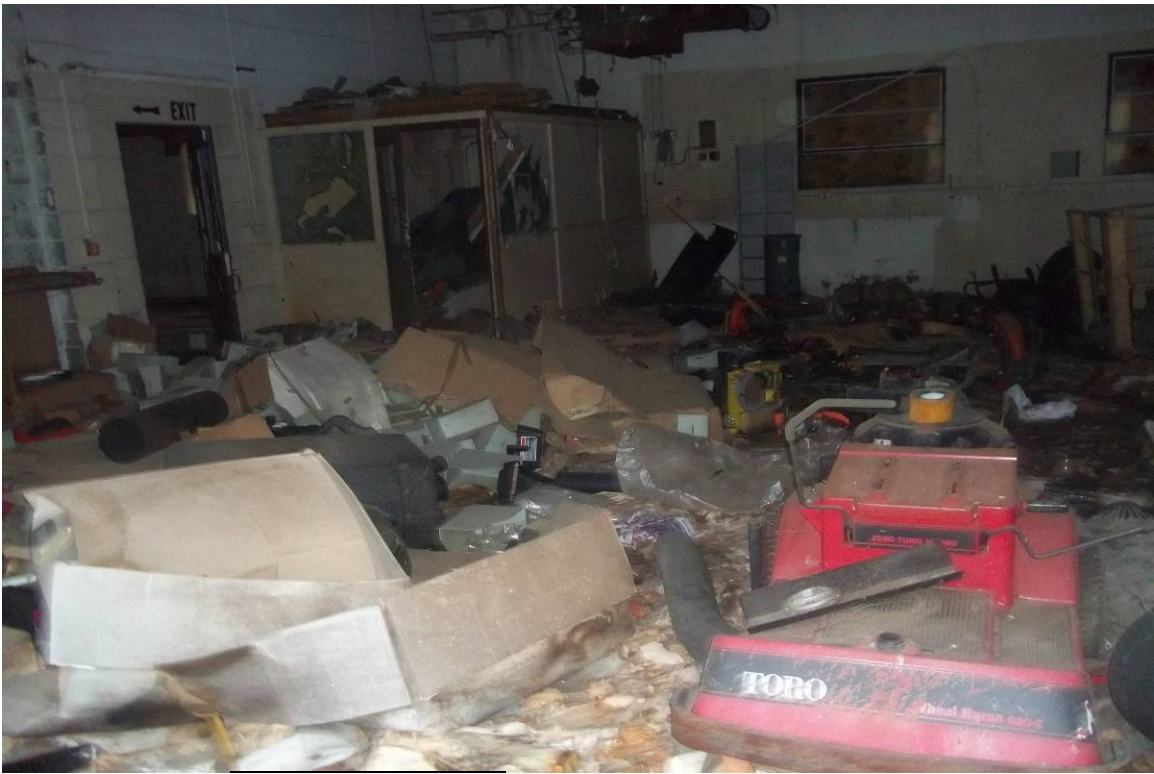
**Date/Time:** 10/25/2012 **Subject:** Northeast section of Building S-46.

S-46 is an unoccupied, medium-sized (120 by 40 feet) warehouse consisting of concrete block and a metal roof. It was historically used as a boiler house, equipment storage, machine shop, and offices. Previous reports stated that it was most recently used to repair and maintain small engine equipment, such as lawn mowers. An empty AST is present on the ground south of the building.

E & E recommends disposing the empty AST on the side of the road that may have contained fuel oil. E & E recommends collecting a soil sample beneath the AST and collecting a sample of the contents (if the AST is not empty) for general characterization purposes and for use in the FFS. Also collect two concrete chip surface samples from the floor for FFS disposal purposes.

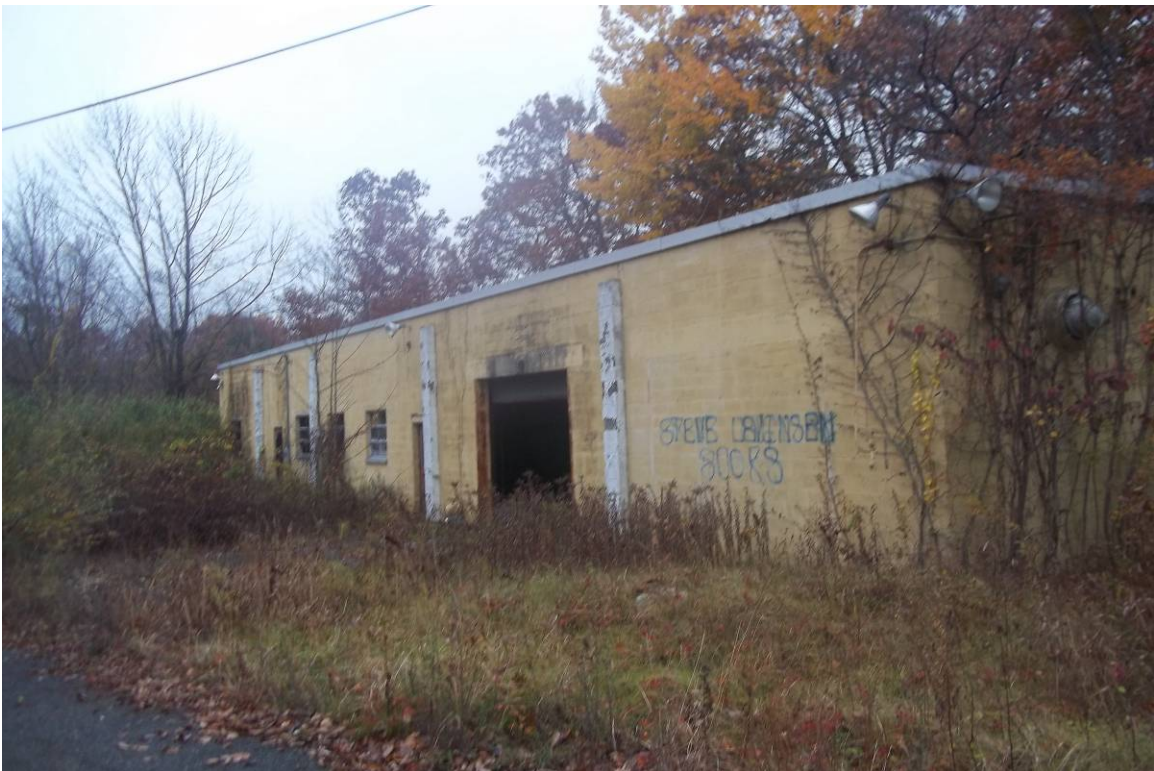
**Date/Time:** 10/25/2012 **Subject:** Exterior of Building S-46.

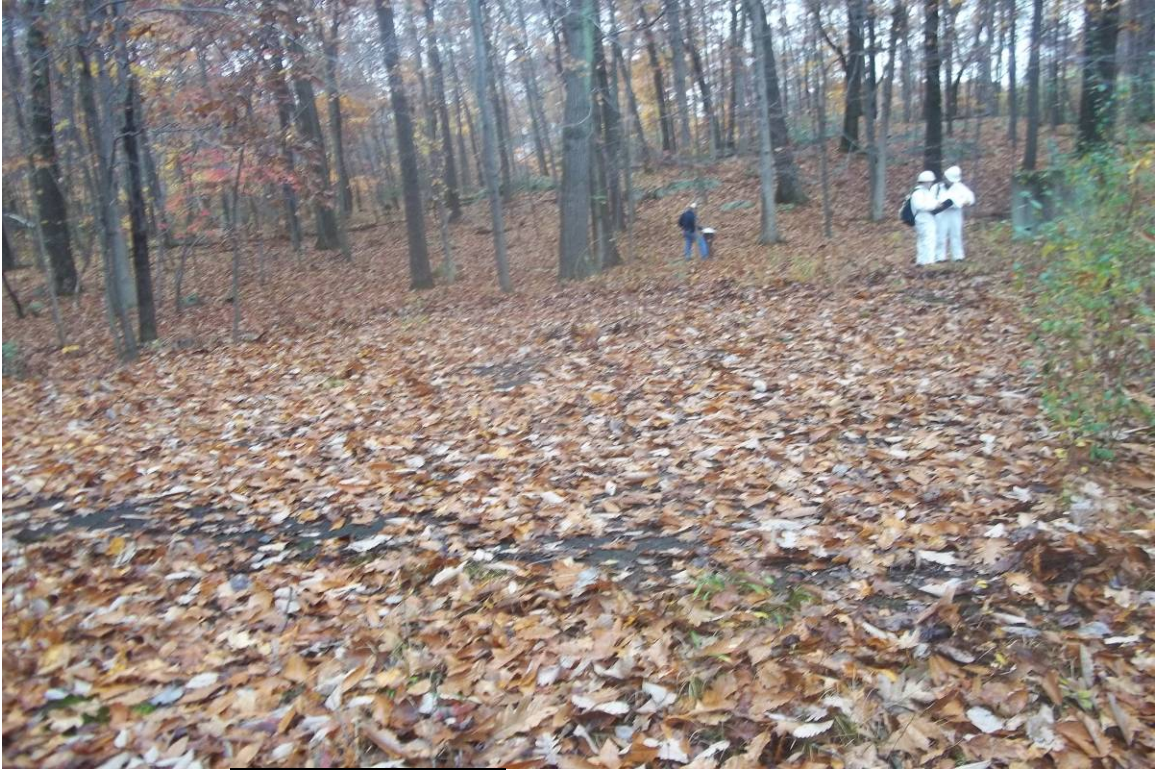
**Date/Time:** 10/25/2012 **Subject:** Concrete pad to the north of Building S-48.

S-48 is a bare concrete pad (approximate 30 by 40 feet). It was historically used for equipment storage, lawnmower repair/salvage shop, and a private automotive repair garage. The building was removed sometime after 2005.

E & E recommends collecting two concrete chip samples from the concrete pad for use in the FFS.

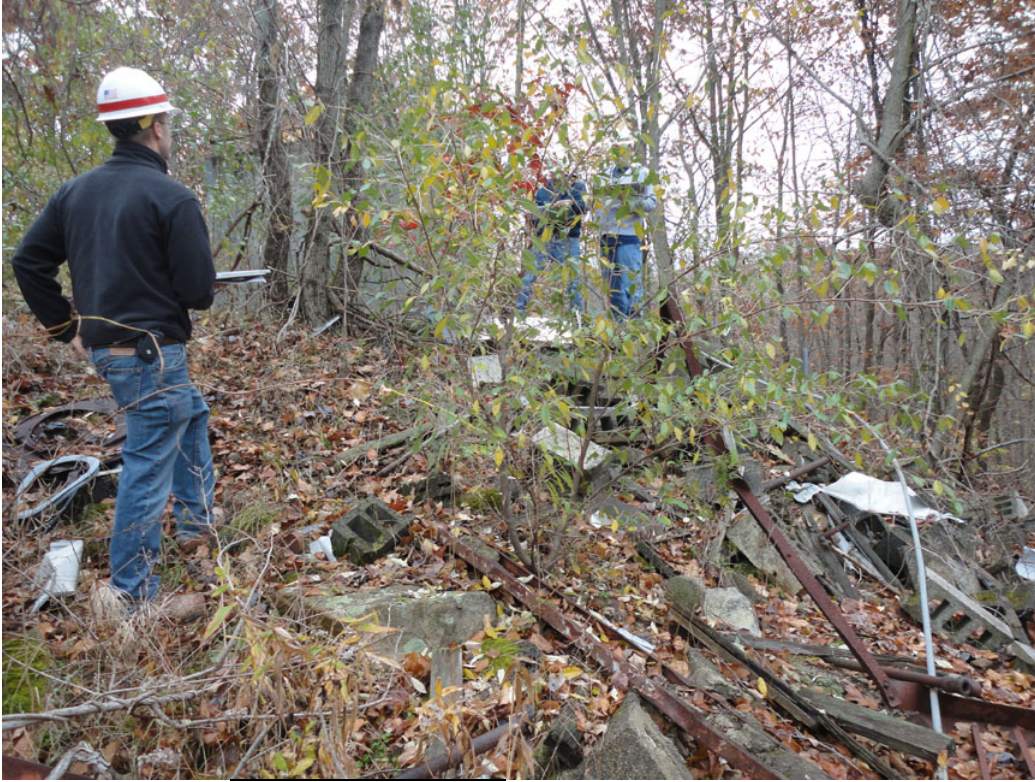
**Subject:** Debris pile containing cinder blocks, metal, wood, etc. at S-49.

Recommend collecting two samples from the debris pile for use in the FFS and to determine how to dispose of the debris. Also recommend collecting one water sample and one sediment sample from the cistern, if accessible, for general characterization purposes and for use in the FFS.

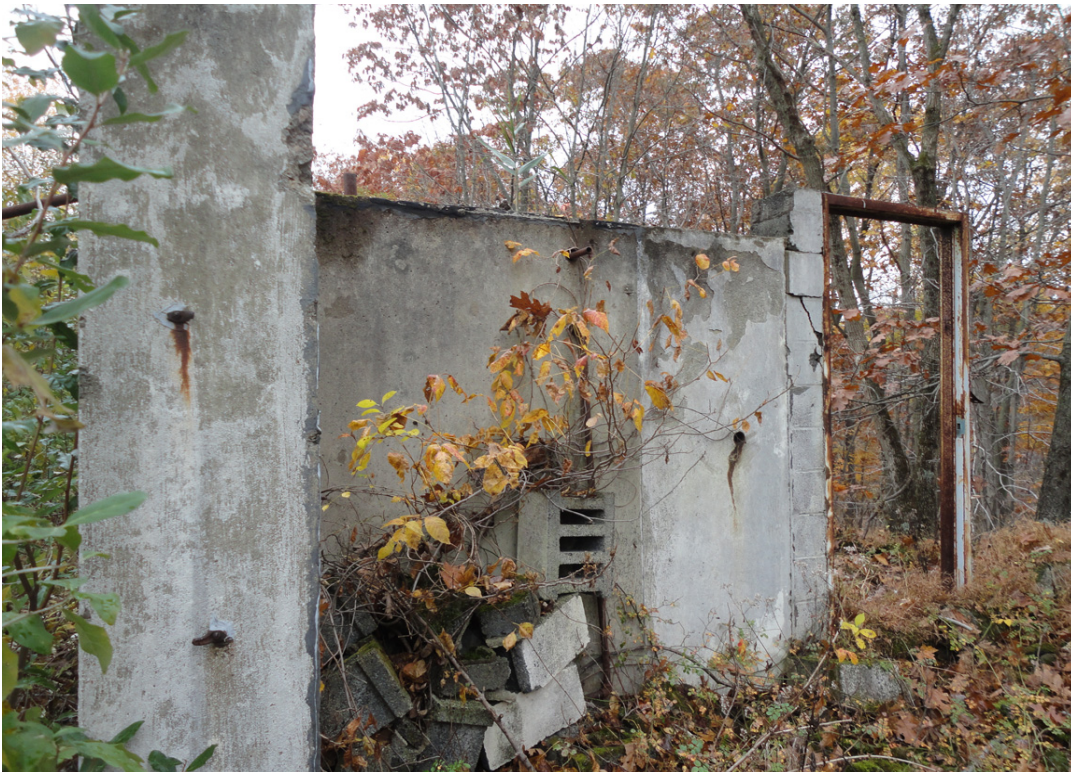
**Subject:** View of remaining concrete wall at S-49.

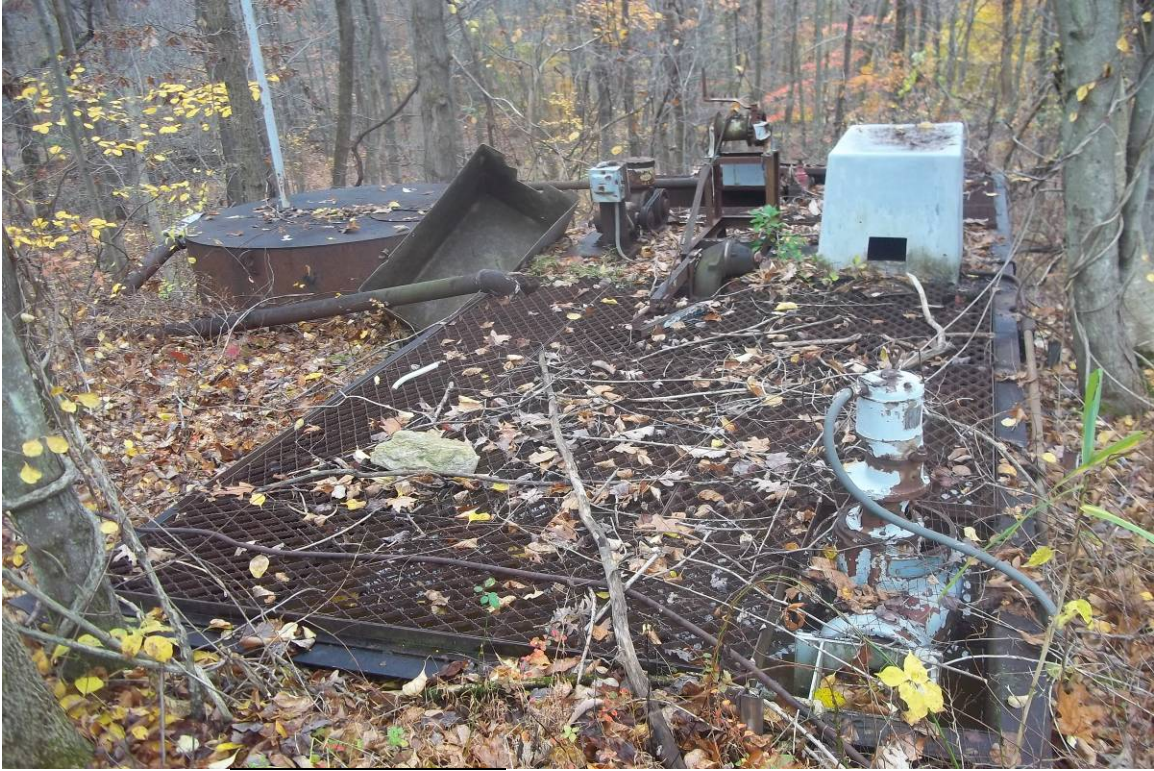
**Subject:** View to the south of sewage treatment area  
within the South Stand Area.

The former No. 1 Sewage Treatment Plant currently contains a separator chamber and an effluent tank. Only one soil sample was previously collected side gradient to the treatment plant. E & E recommends collecting a water and sludge sample from the treatment plant and an immediately downgradient surface soil sample. These samples will be collected for general characterization purposes and for use in the FFS.

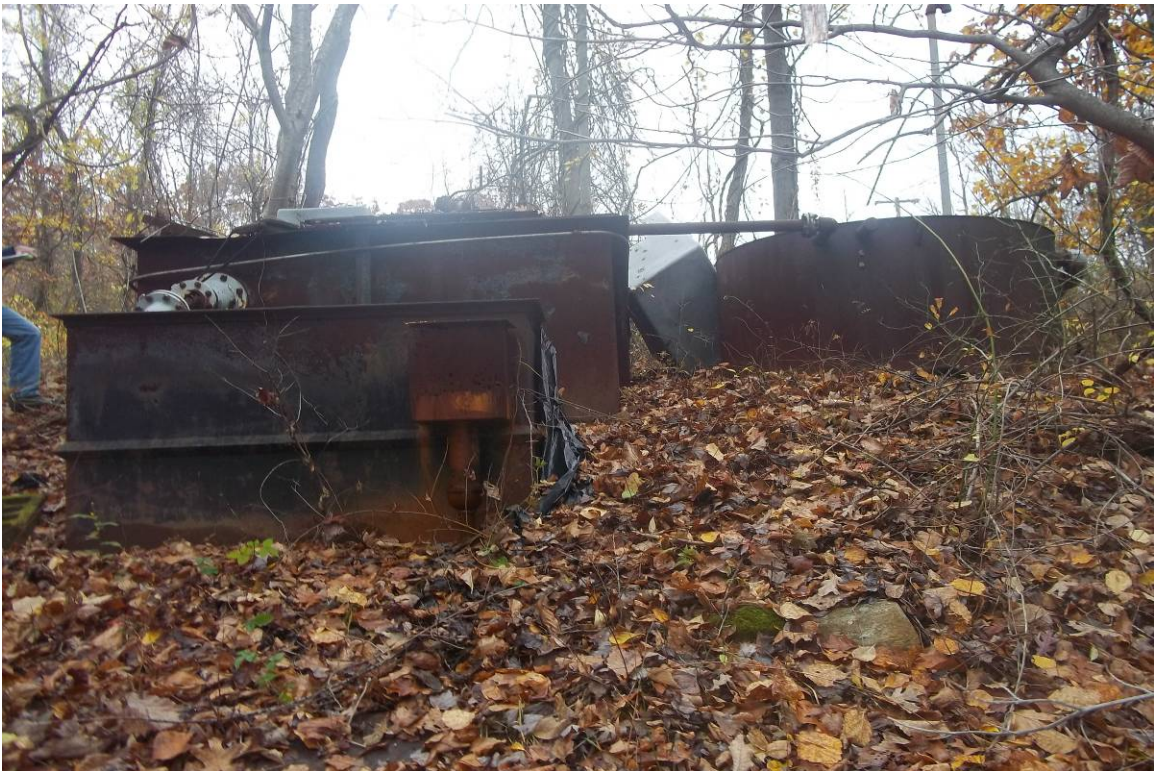
**Subject:** Looking north from the downgradient side of  
the sewage treatment area.

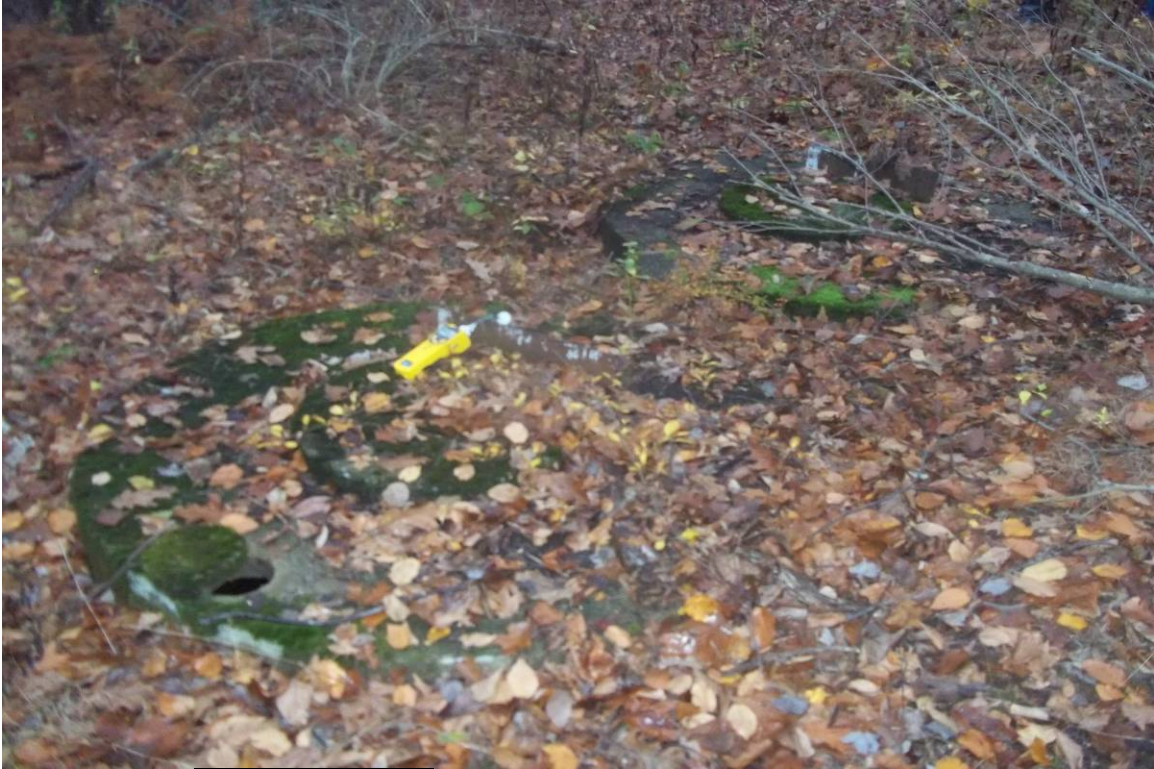
**Date/Time:** 10/26/2012 **Subject:** Possible cisterns due east of R-47 in East Stand Area.

Cistern/Cistern Pump	The Cistern/Cistern Pump consists of two, 6-foot diameter concrete lids on buried vaults adjacent to a 4-foot by 6-foot concrete slab. These vaults were observed to be filled with water during the site walkover.	No description available
No. 2 Sewage Treatment Plant	The No. 2 Sewage Treatment Plant consists of a separator chamber and effluent tank.	Sewage treatment.
Scrubber	The scrubber is unused and only a bare concrete foundation remains. The scrubber collected material from rocket tests performed at Test Stand (R-3). The material would have passed through the scrubber, into what appears to be a settling basin with an overflow that ultimately discharged to the west through an opening.	Scrubber building designed to clean exhaust gases from test firings of rocket motors.
Water Cooling Tower	The Water Cooling Tower is a wooden structure with two large fans on the roof and a concrete foundation.	Water cooling tower.

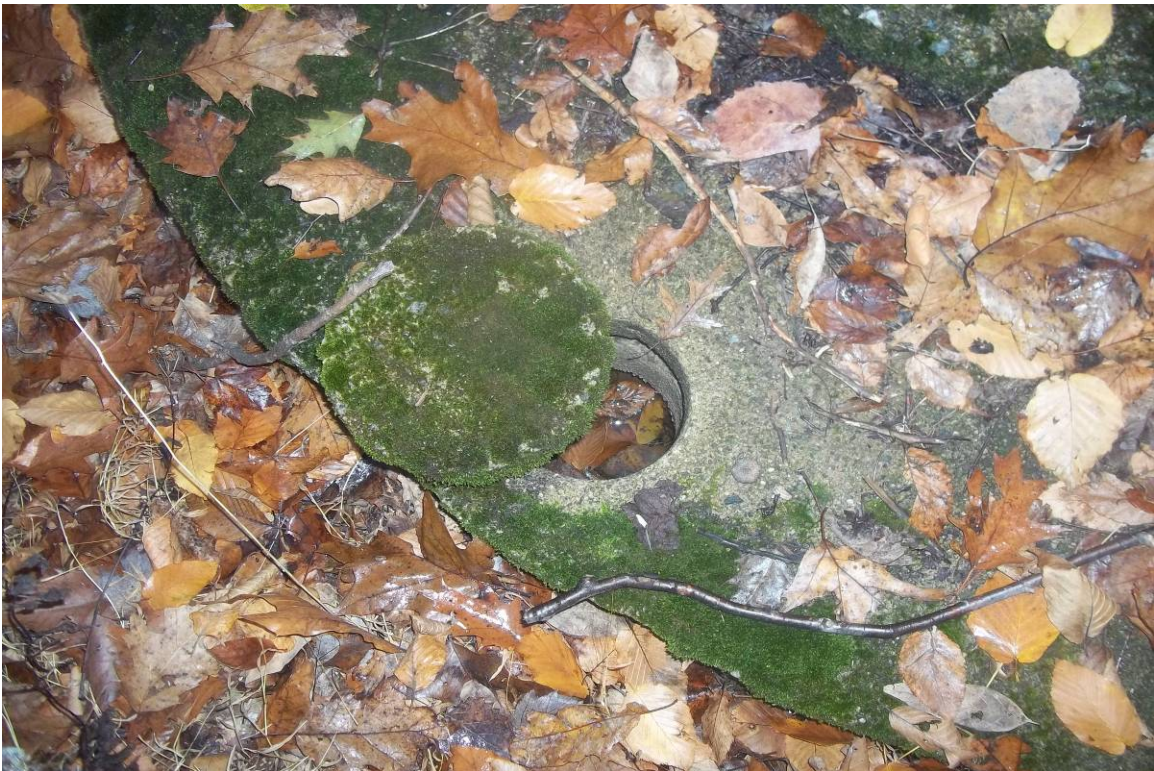
**Date/Time:** 10/26/2012 **Subject:** Close-up of possible cistern due east of R-47 in East Stand Area.

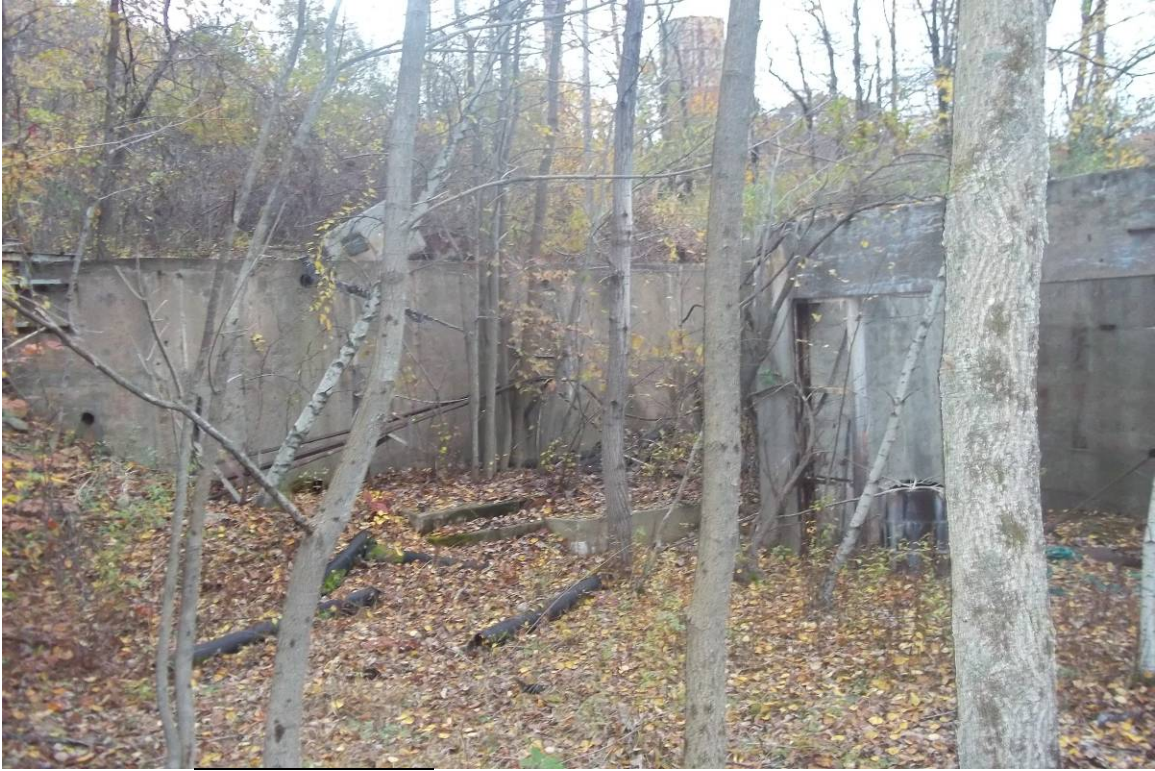
**Subject:** Exterior of test stand #3 (R-3).

Test Stand 3 (R-3) contains one concrete test bay. It was historically used as a rocket motor test stand with exhaust scrubber/effluent treatment. Two abandoned ASTs were observed lying on the ground on the north side of the structure.

Recommend collecting surface soil samples near the ASTs unless additional information is obtained indicating that the ASTs were properly decommissioned. E & E also recommends collecting one surface soil sample from the floor of the test bay for general characterization purposes and for use in the FFS, and two concrete chip samples from the walls and floor of the test bay for disposal purposes and for use in the FFS.

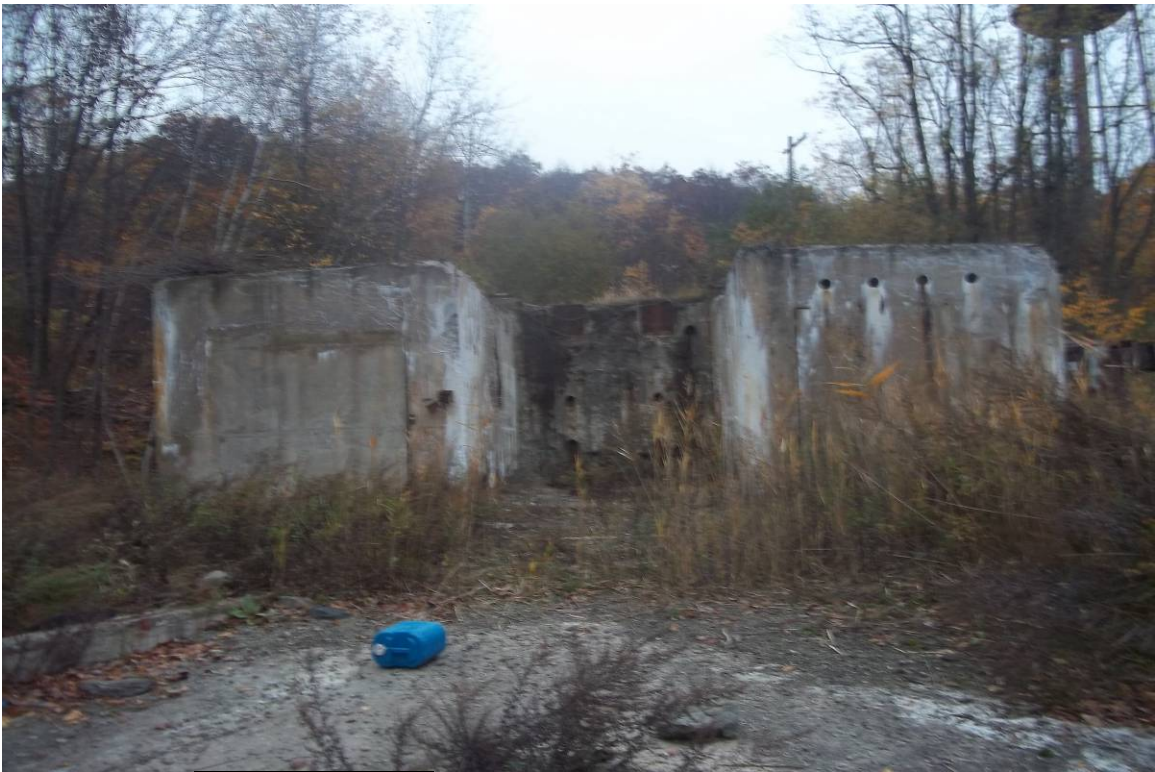
**Subject:** Exterior of test stand #3 (R-3).

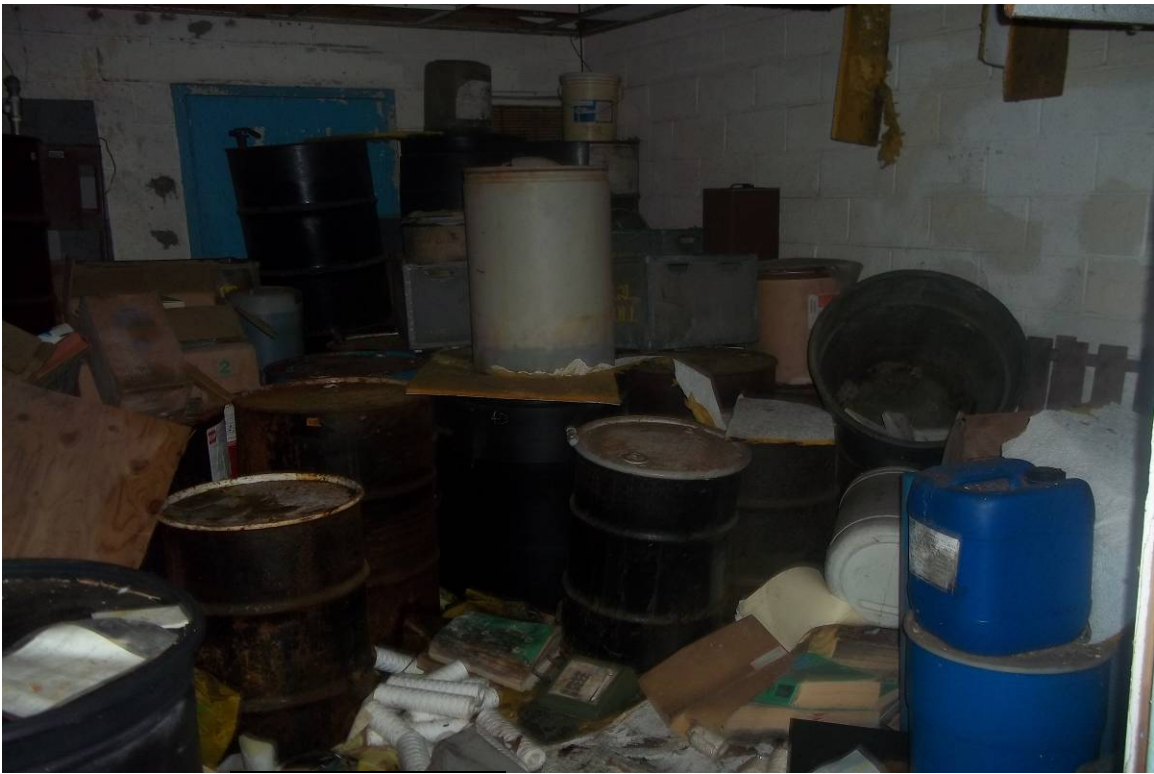
**Subject:** Southwest room in R-21 with multiple 55 gallon drums.

This building contains approximately 30 drums/containers (55-, 30-, and 5-gallon), and other debris. E & E recommends hazard categorization and proper disposal of the drums/containers. In addition, collection of one concrete chip sample from the drum room and one composite surface soil sample from around the building for general characterization and disposal purposes, and for use in the FFS.
